Electrical and Structural Characterization of Web Dendrite Crystals

G. H. Schwuttke
Arizona State University
Tempe, AZ 85287

K. Koliwad and K. A. Dumas
Jet Propulsion Laboratory
California Institute of Technology
Pasadena, CA 91109

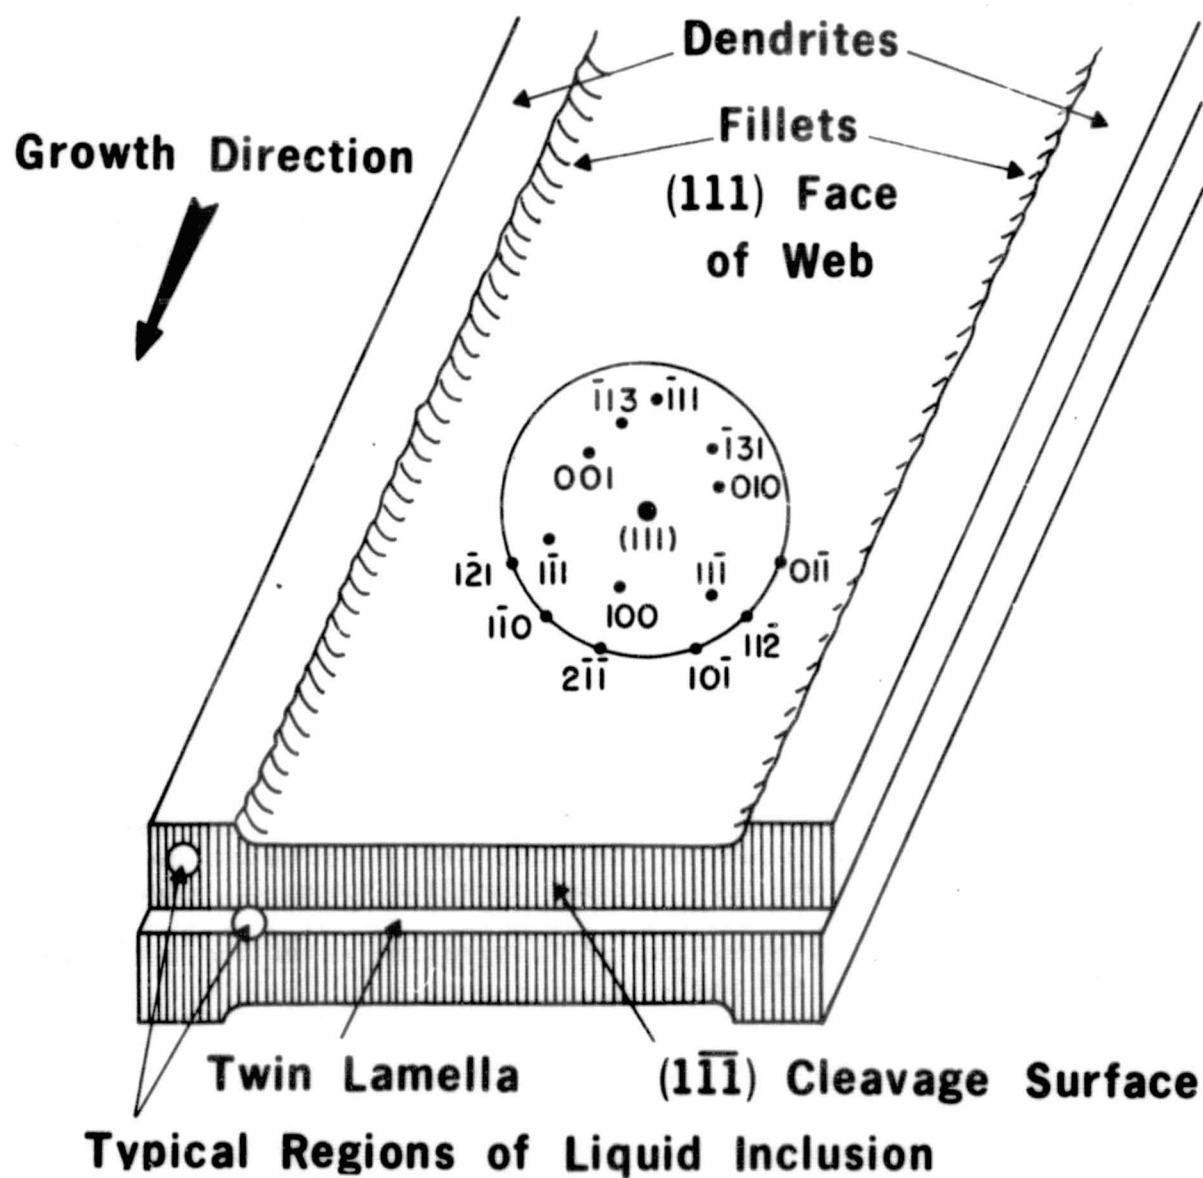
Fig. 1a Web Crystal Geometry

The web surface is parallel to the (111) plane, and the web pulling direction is $[2\bar{1}\bar{1}]$. A cross-section of web shows its most prominent structural feature: multiple twin lamellae in the center of the web covered by two thick (100 μm) surface layers which are also in twin relation. An example is shown in Figs. 1a,b.

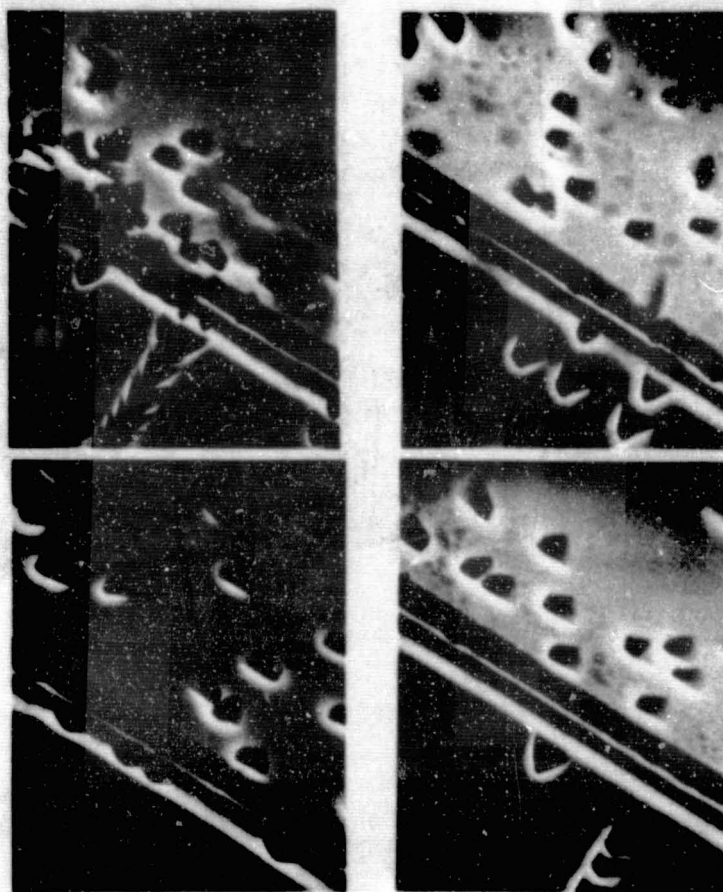
Fig. 1b SEM-micrograph of cleaved web cross-section after preferential etching. Note twin lamellae in center.

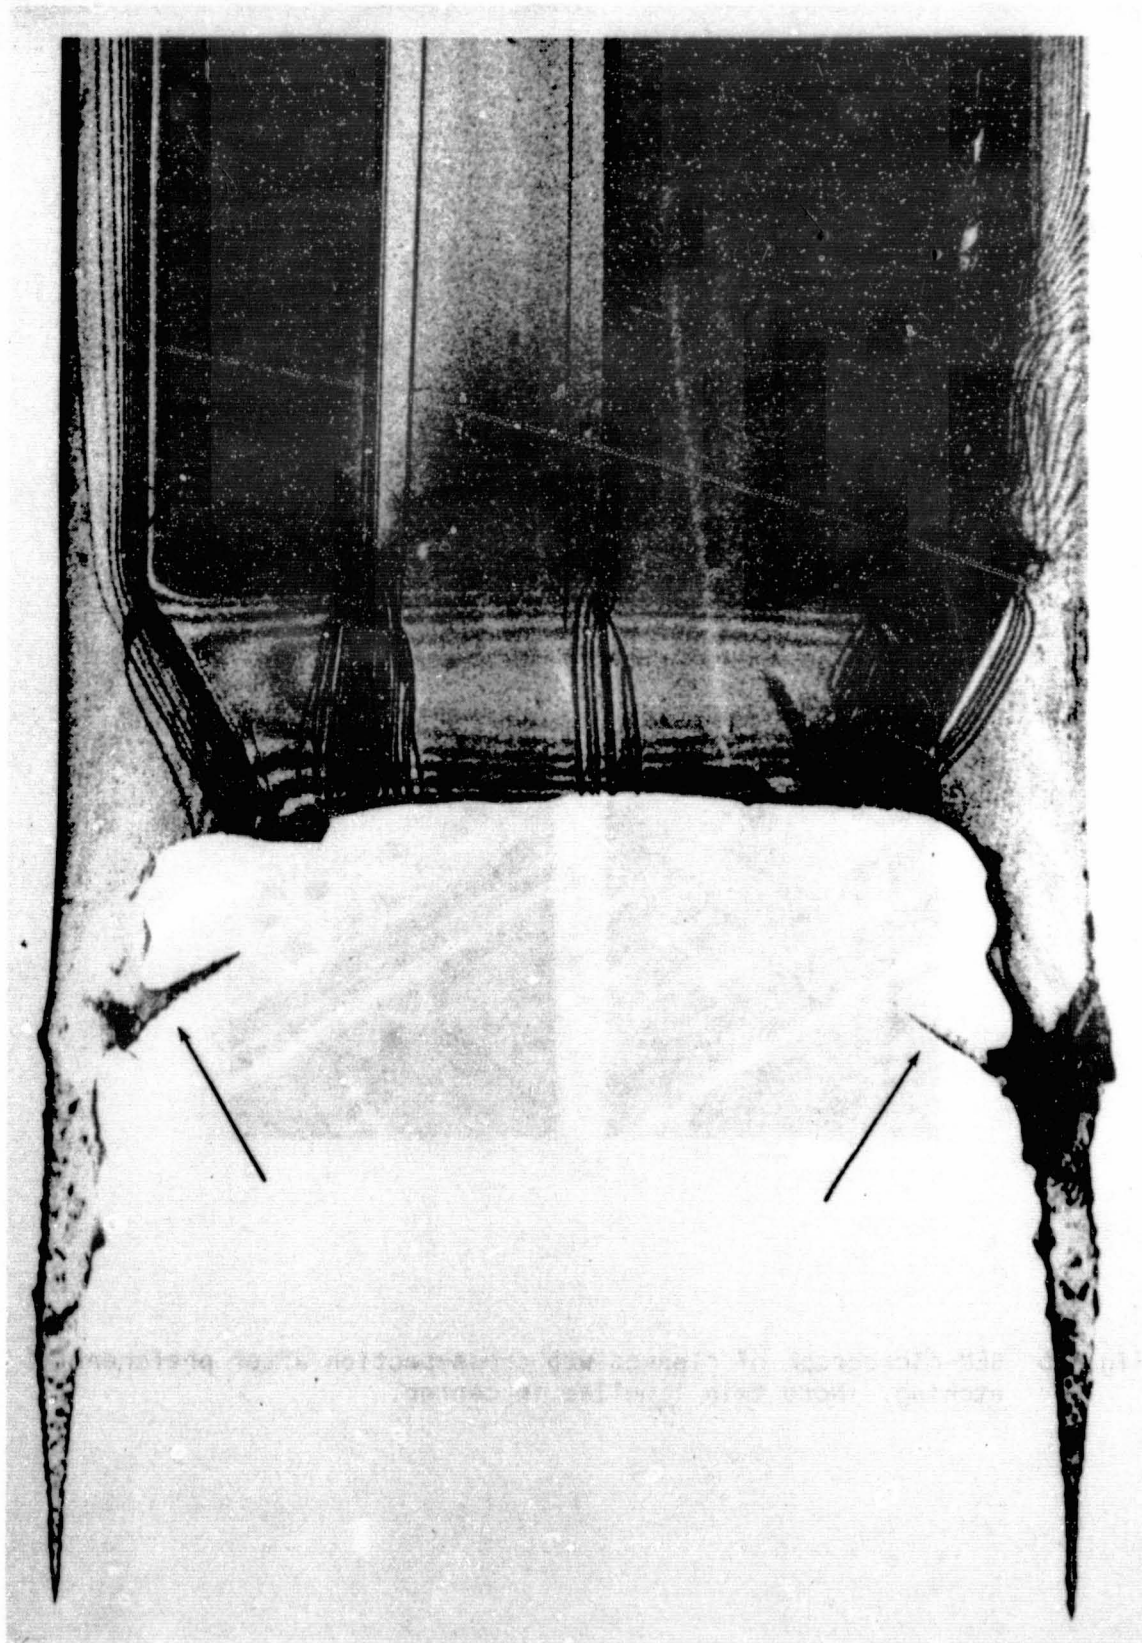
Fig. 2 SOT X-ray topograph of 2 cm wide web dendrite. Note wing growth (arrows) at dendrites below web leading to liquid entrapment and dislocation generation during growth.

Dislocations in web are generated through "melt entrapment" caused by "wing" growth along the dendrites (Fig. 2). Propagation of such dislocations depends on the curvature of the solid-liquid interface of the web during growth. An interface curvature of concave downward concentrates the dislocations in the center of the web (Fig. 3). Webs grown with a straight interface concentrate the dislocations in the fillet region. Thus the web grows free of any dislocations (4), Fig. 4. Most webs of today contain bundles of very long dislocation lines parallel to the $[2\bar{1}1]$ direction (Fig. 5). They are piled up against the twin planes. In addition, annealed web contains large area stacking faults. The electrical activity and the influence of these faults on solar cell efficiency has not yet been investigated. Such an influence is assumed to be relatively small but it may be of importance for high efficiency solar cells. These defects are described in more detail in References 3 and 5, examples are shown in the x-ray topographs of Figs. 6.

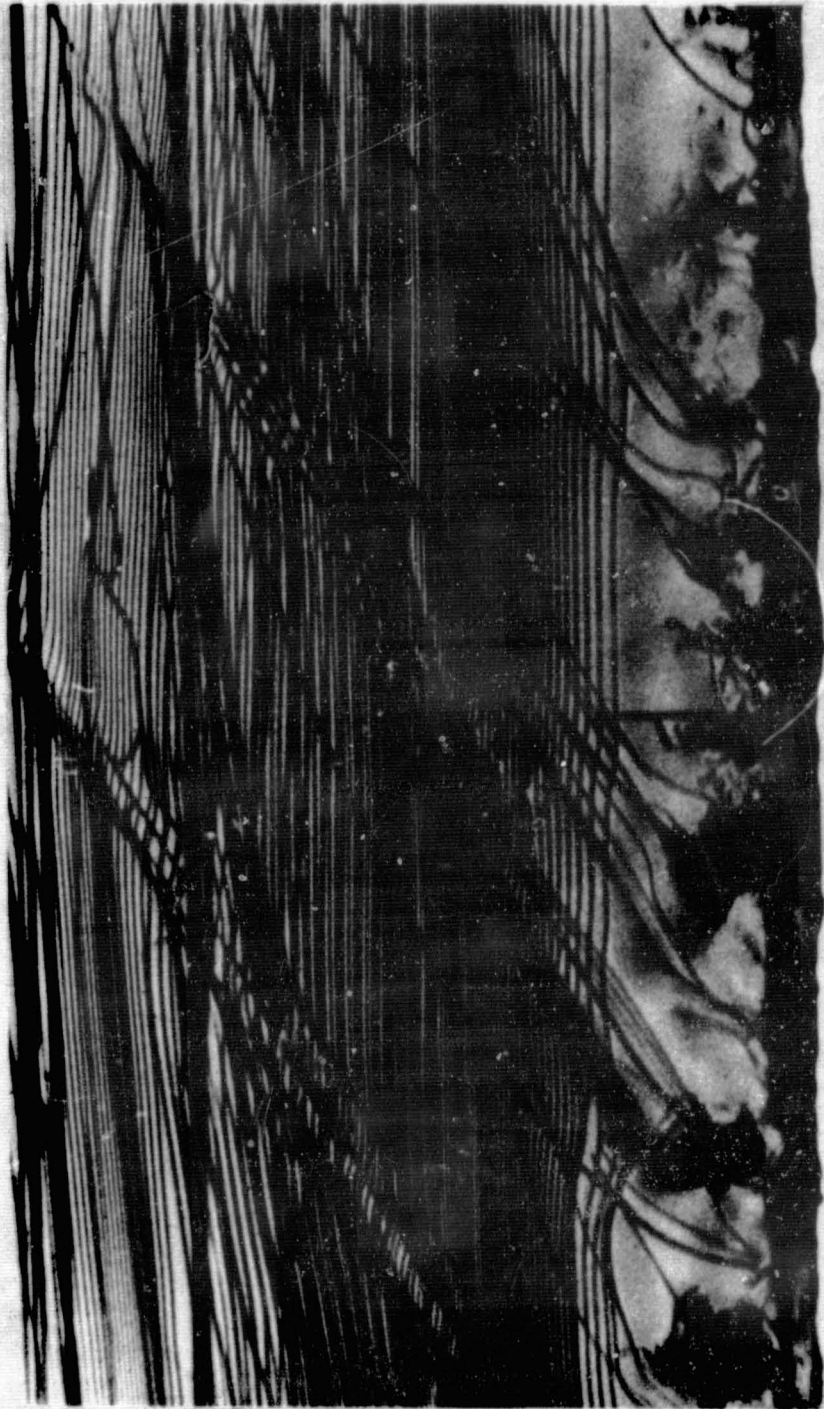
Fig. 3 SOT X-ray topograph of 3 cm wide web dendrite. Note dislocation generation at stress centers and propagation of dislocations during growth toward center.

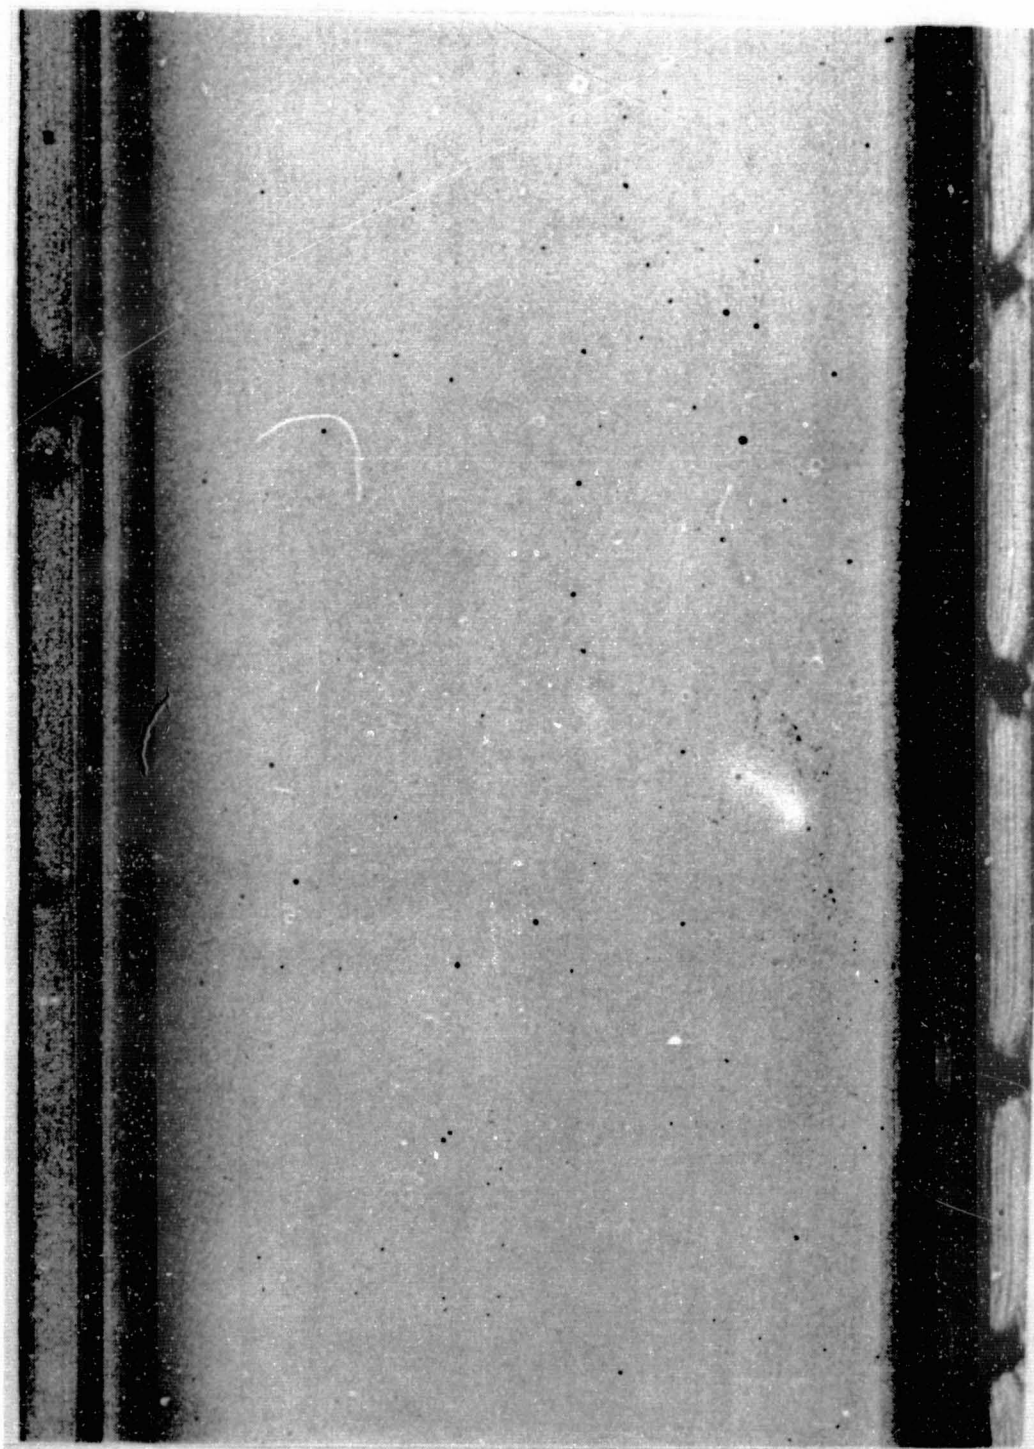
Fig. 4 SOT X-ray topograph of perfect 1.5 cm wide web. Dislocations are trapped in fillet region.

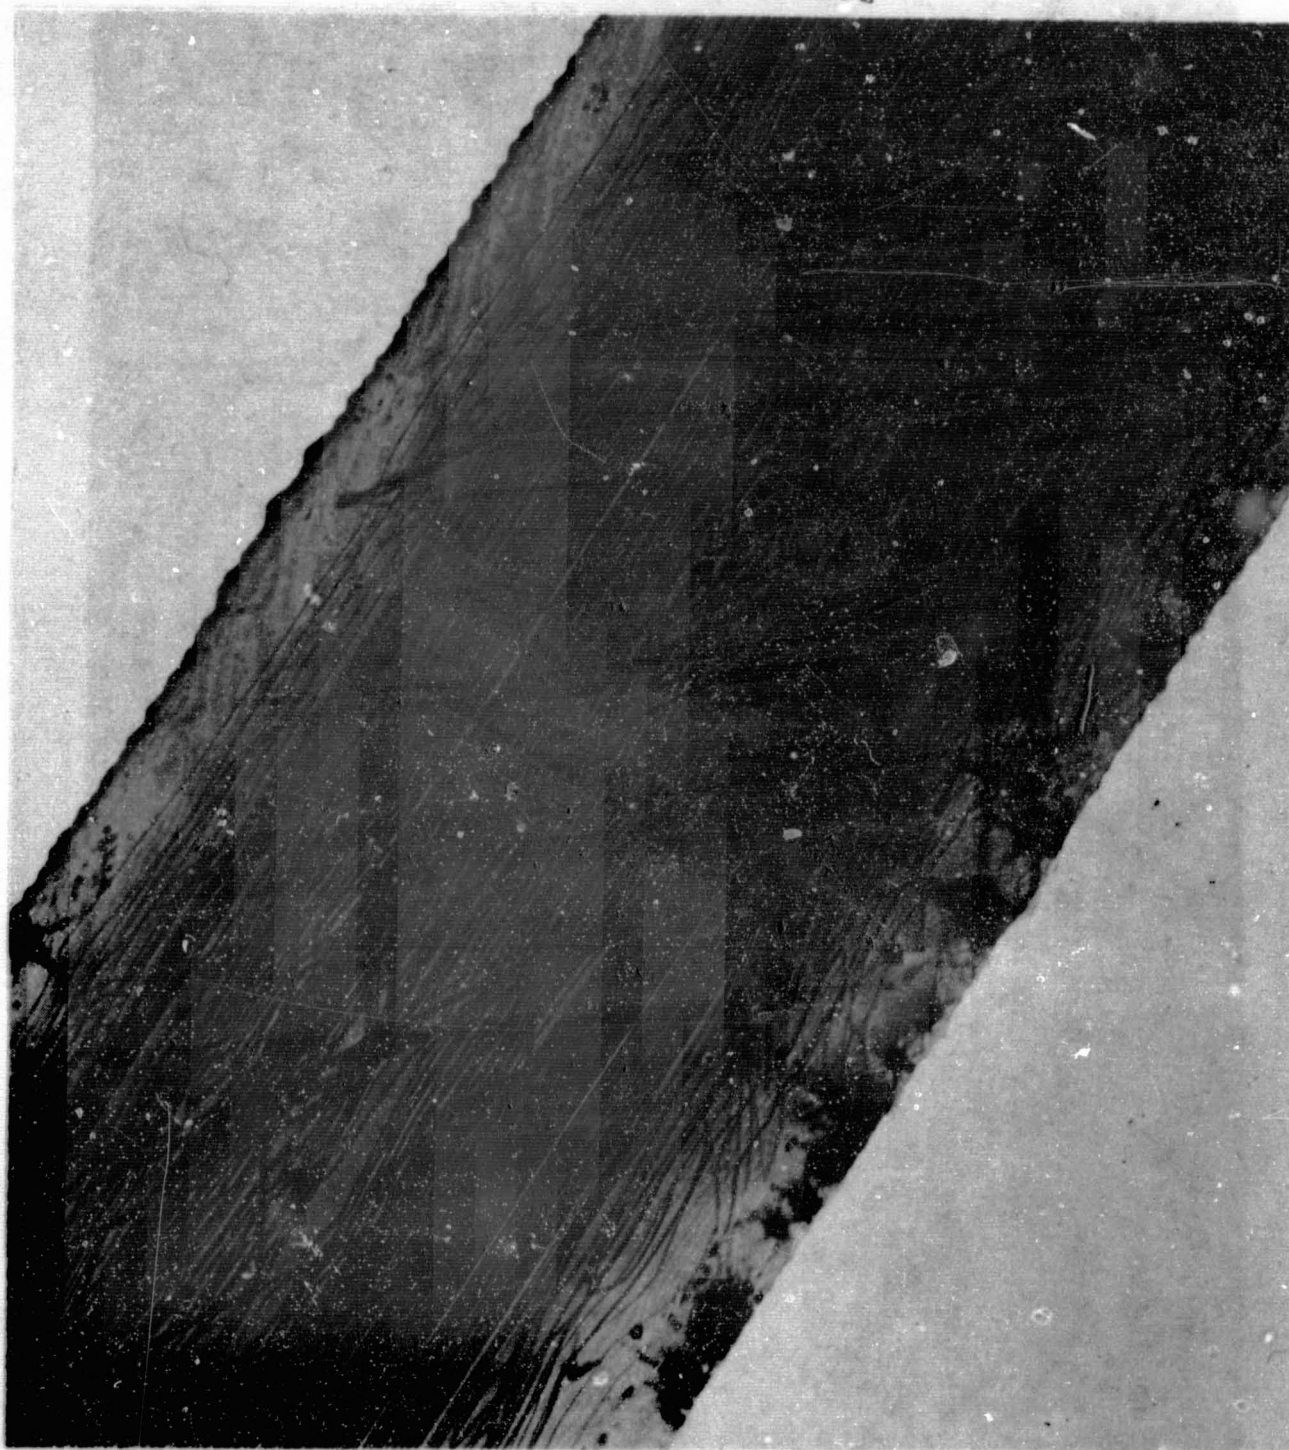
Fig. 5 SOT X-ray topograph of high performance web, 220-reflection. Note long dislocations, 73 degree type; Burgers vectors $[101]$, $[110]$. Low electrical activity.

Silicon web dendrite sections of various quality (Figs. 5, 6, 7) were evaluated through minority carrier lifetime "mapping" using 1.5 mm diameter MOS capacitors. The total number of MOS capacitors per web section was 300. The MOS dots were arranged into 15 rows. The dendrites were included into the evaluation. The dimensions of the web sections were 2 inches long and 32 mm wide. The webs were evaluated after each oxidation cycle (15 min wet-110 min dry-15 min wet at 1000°C. Three or four consecutive oxidation cycles were used. Minority carrier lifetime maps of the total web section were obtained after each oxidation cycle by measuring the lifetime under each capacitor as described by Fahrner & Schneider (6). Subsequently, the lifetime was computer plotted versus its position on the web surface. Local lifetime degrading defects revealed by such lifetime maps were analysed by advanced characterization techniques. A result typical for web sections of quality as shown in Figs. 5 and 6 is given in Fig. 8. This figure summarizes the influence of high temperature heat cycles on minority carrier lifetime. The lifetime data are displayed in 6 maps. Each map represents a matrix of 300 capacitor dots. The maps on the left side of the figure carry the label oxidation 1 to 3 and represent the lifetime data obtained after the first, second, and third oxidation cycle. The devices were obviously stripped before every successive oxidation step. The z-scale represents the measured lifetime values in microseconds. The range of lifetime data present on the web section is also included in the label. For instance, the minimum lifetime obtained at a specific location (capacitor) after the first oxidation was 0.274 microseconds. The maximum lifetime is 207 microseconds. The lifetime map shows a relatively smooth plateau. Noteworthy is, that this plateau extends over the total web section surveyed. Accordingly, this web is of excellent crystal quality and compares well with the best Czochralski silicon as available today. Interesting is a comparison of the maps obtained after the first, second and third oxidation. The lifetime plateau obtained after the second oxidation is well above the one obtained after the first oxidation and the same is true for the third oxidation. The third plateau is a little bit lower than the second one. Using Czochralski wafer quality as a standard, the

SCHWUTKE: First of all, the core structure of this grown dislocation is very benign. It makes an angle of 73° , and this type of dislocation has been described in the literature. This structure is very benign, while a 60° dislocation, which is a slip dislocation, is very active due to its core structure.

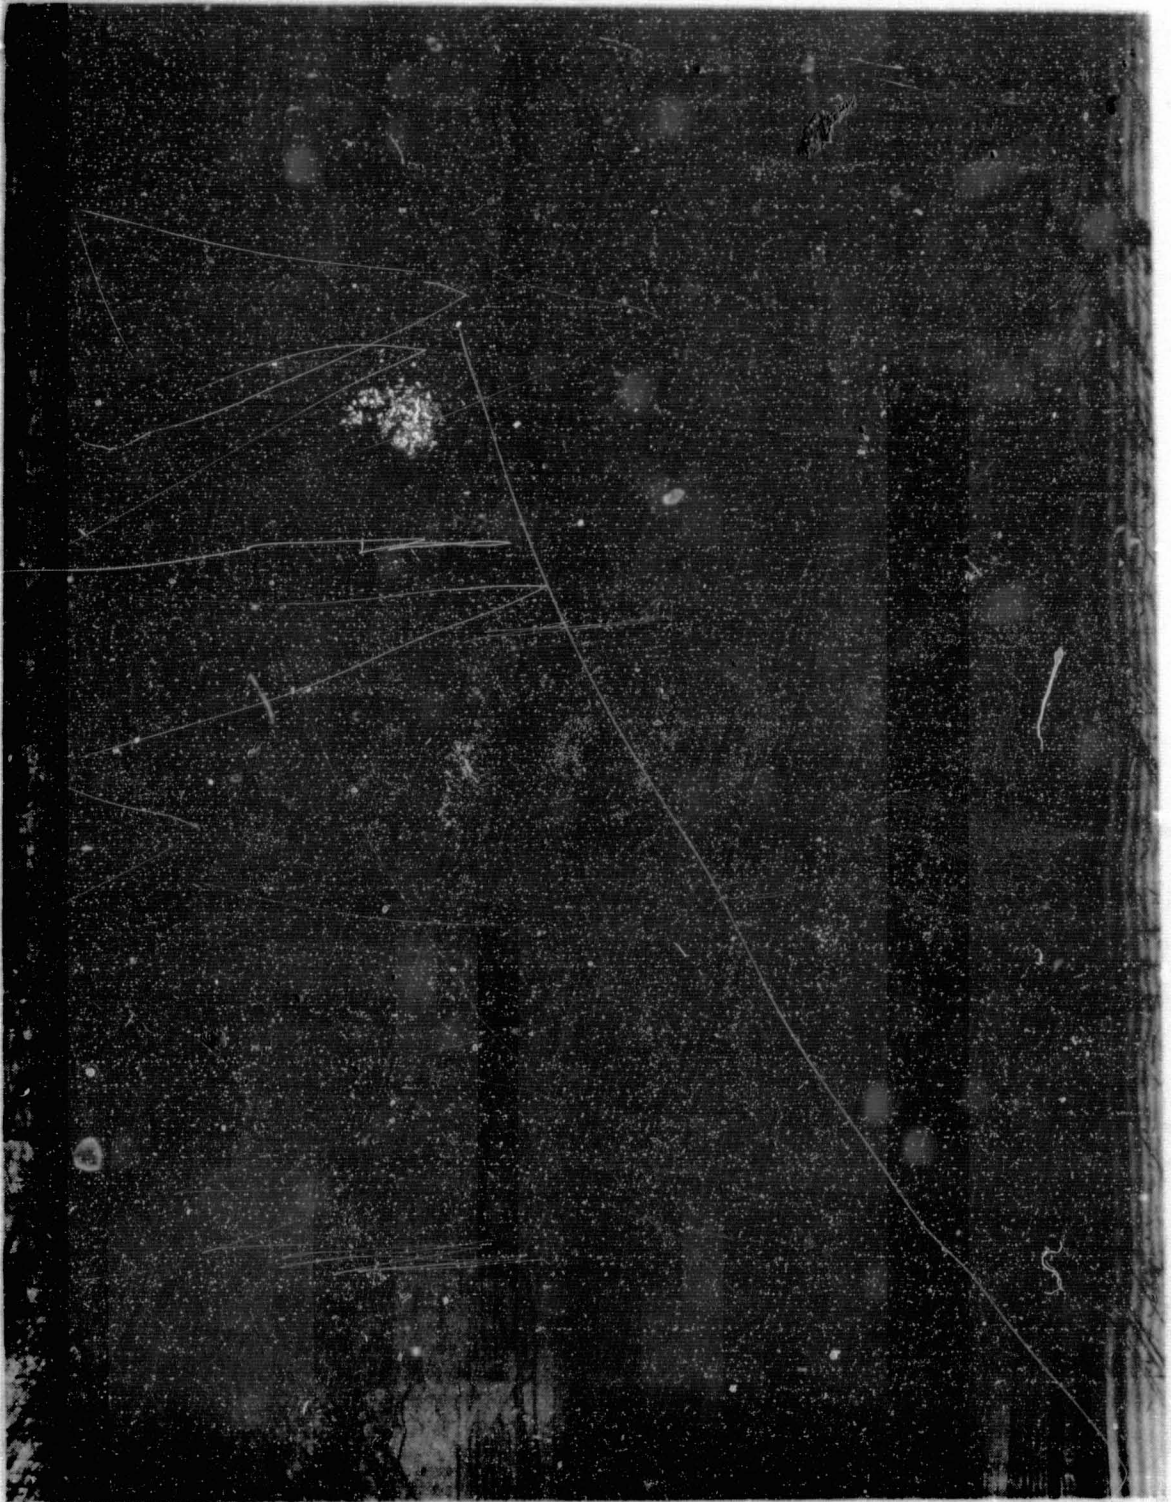
Fig. 6a SOT X-ray topographs of high performance web. Width 3.2 cm.
(111) reflection: Surface twin lamellae.
Electrical data in Fig. 8.

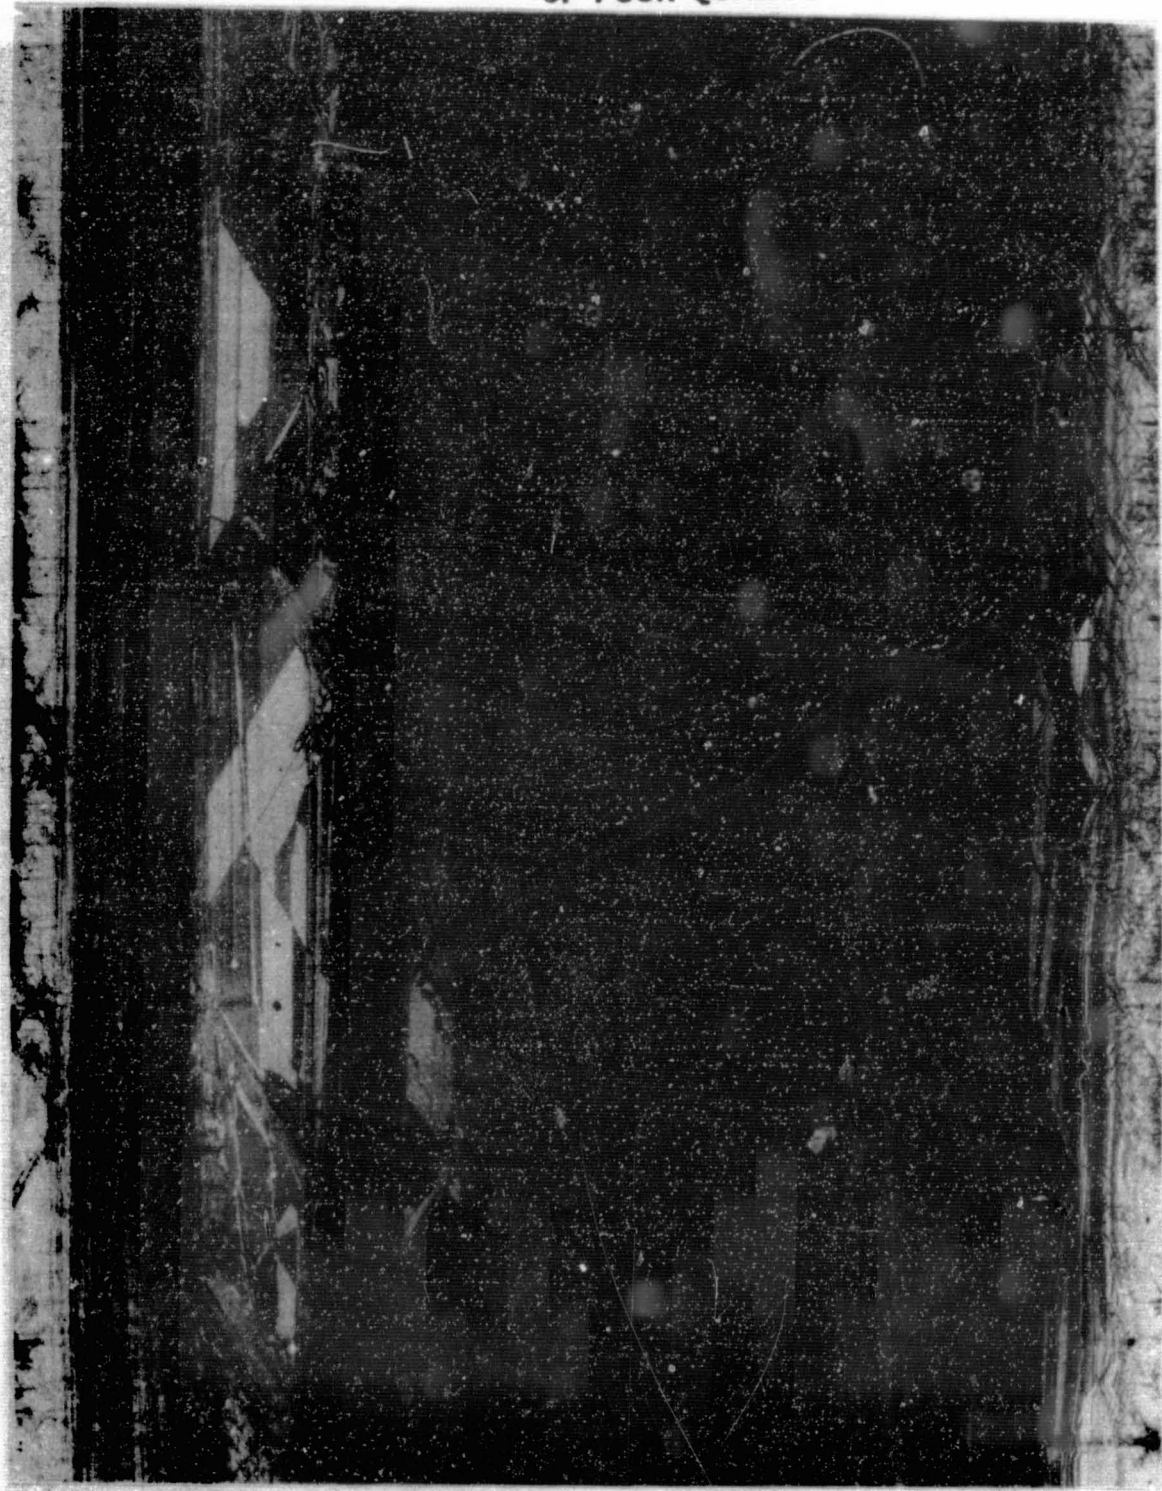
Fig. 6b SOT X-ray topographs of high performance web. Width 3.2 cm.
(111) reflection: Bottom twin lamellae
Note difference in crystal perfection: Bottom lamellae contains
large area stacking faults. Topographs recorded after third
oxidation. Electrical activity of defects low.

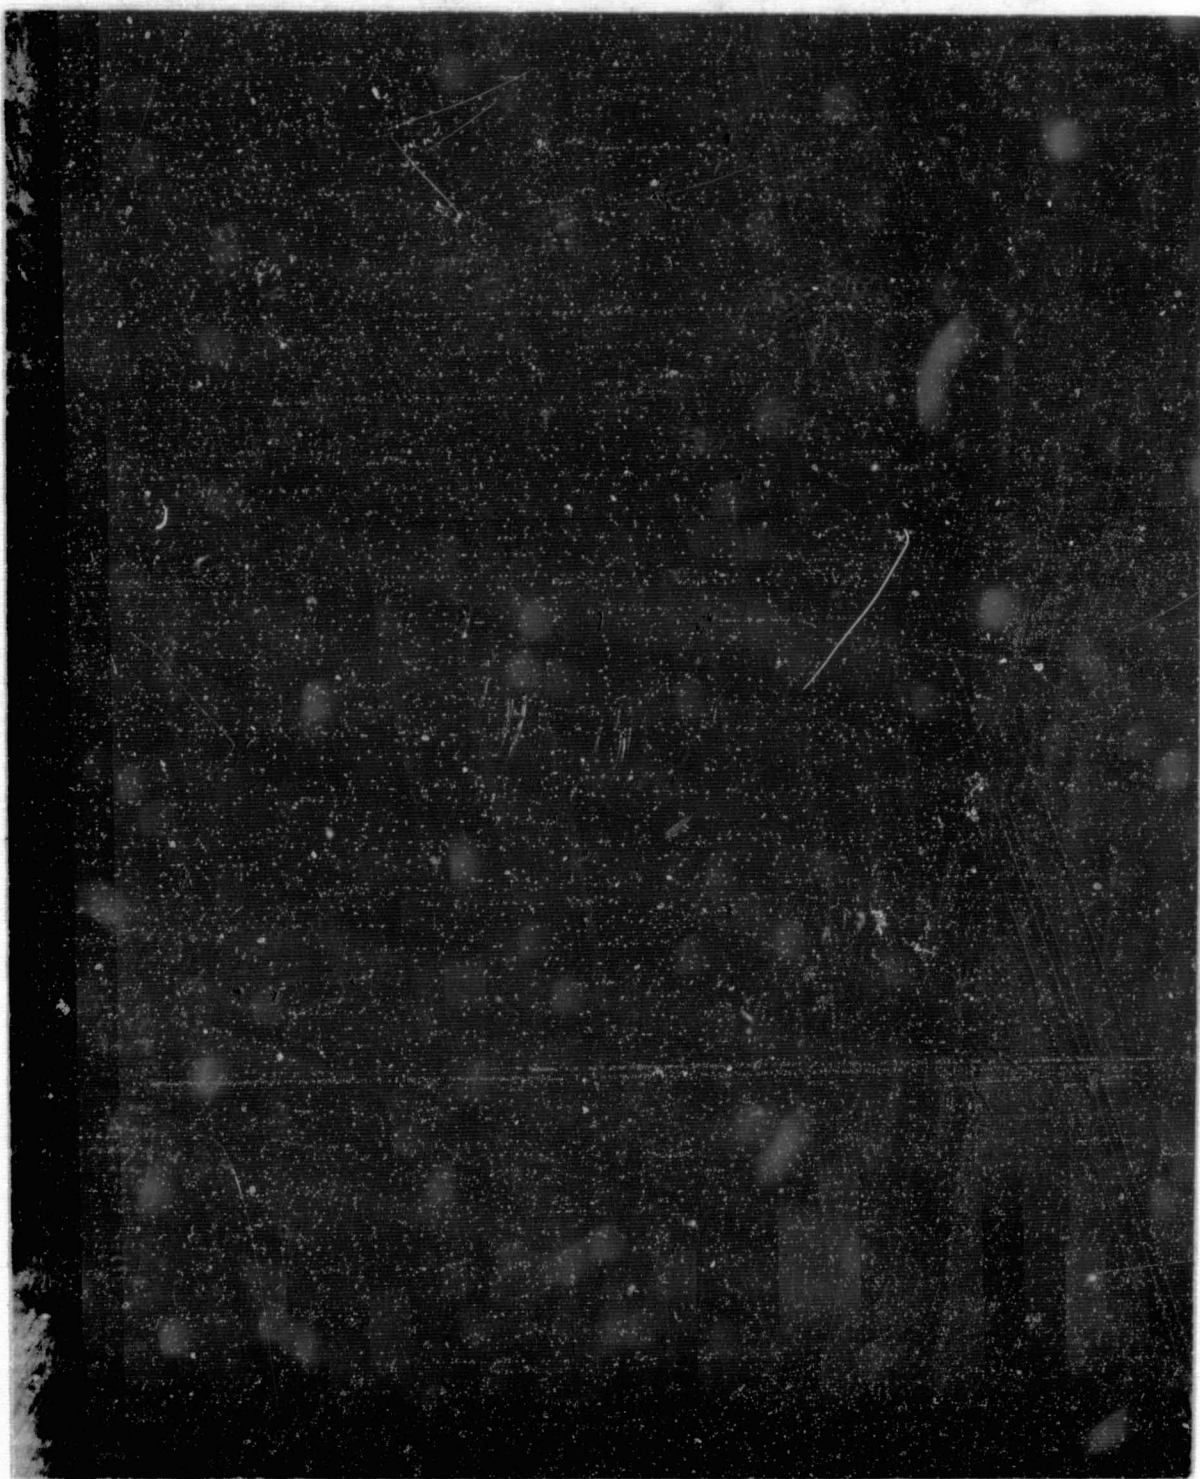
Fig 7a SOT X-ray topograph of low quality web. Note slip dislocations.
Electrical activity high. Lifetime range: 0.01 - 1 μ sec.

If excessive stresses are present during web growth (buckling) large numbers of slip dislocations and small angle grain boundaries may occur. Such defects degrade minority carrier lifetime. An example is shown in the x-ray topographs of Figs. 7.

Web material of the quality as displayed in the topographs of Figs. 7 do not give comparable results. It was found that the "slip" dislocations - which result from buckling stresses - degrade minority carries lifetime substantially. These dislocations are of the same type as the "process" induced slip dislocation encountered during IC processing. It is known that the electrical activity of these dislocations is high. The lifetime map shown in Fig. 9 corresponds to the sample shown in Fig. 7b. Note the good correlation between low lifetime and defect area in the center of this sample.

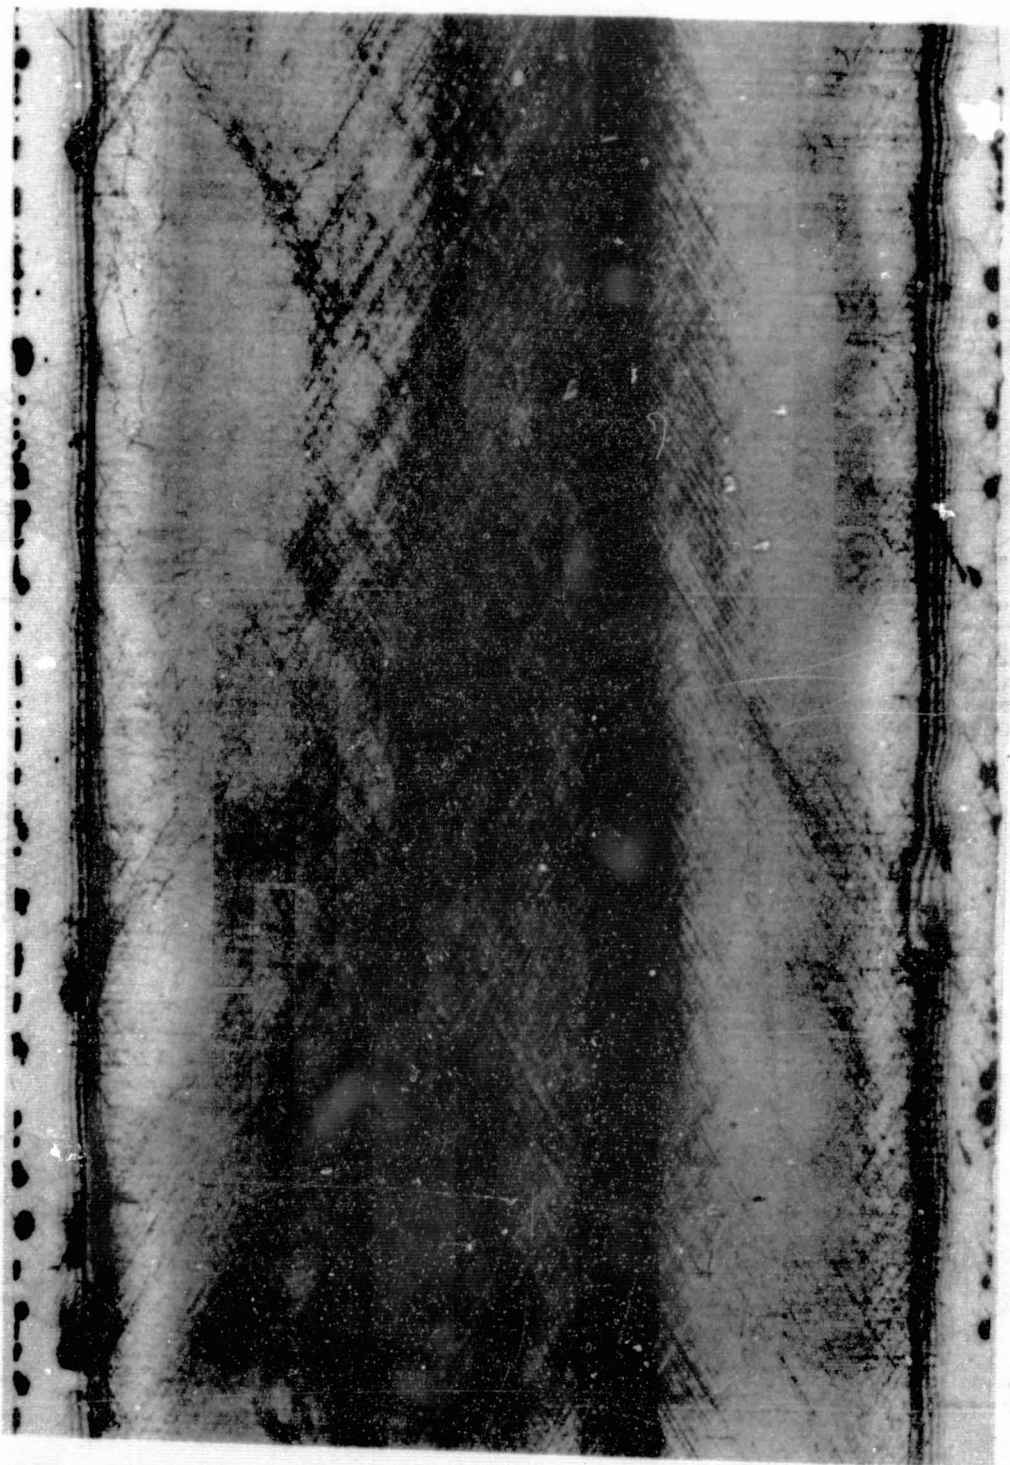
Fig 7b SOT X-ray topograph of medium quality web. Electrical data in Fig. 9.

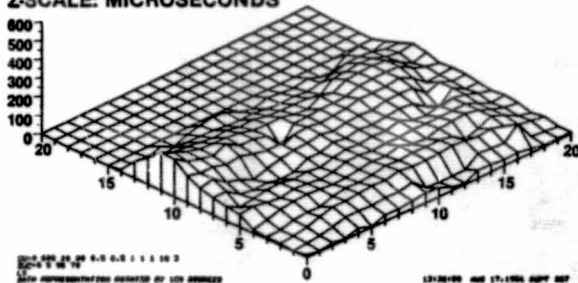
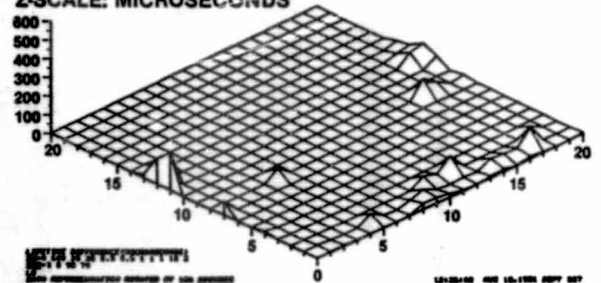
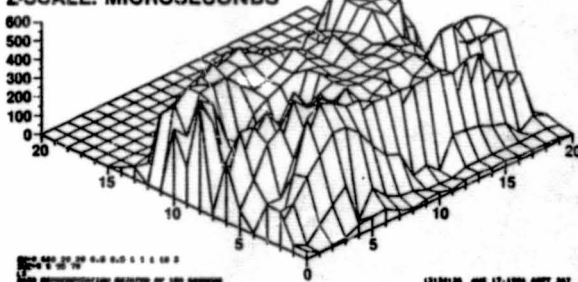
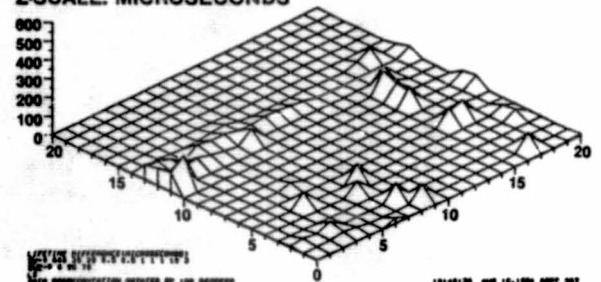
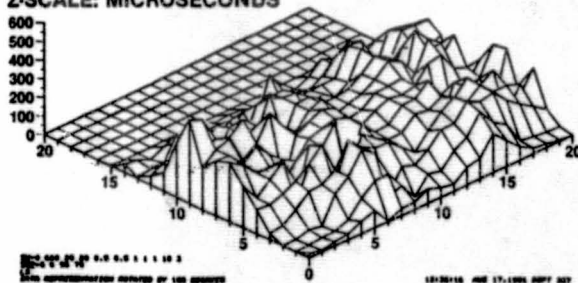
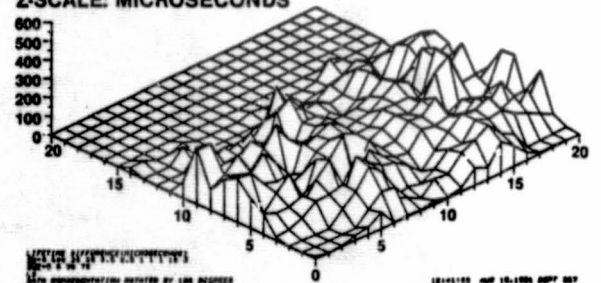
Oxidation 1

Decrease 1 to 2

Oxidation 2

Decrease 1 to 3

Oxidation 3

Increase 1 to 3

Fig. 8 Minority carrier lifetime maps of high performance web.
Lifetime range: 0.2 - 207 μ sec.

material obtained after the third oxidation shows very uniform lifetime distribution data.

The maps on the right side of Fig. 8 are labeled DECREASE or INCREASE. The DECREASE map shows the degradation of lifetime as a result of the second or third oxidation cycle. The INCREASE map shows the area where the lifetime increased after the third oxidation relative to the first oxidation. These maps show clearly the improvement of lifetime as a result of oxidation. This improvement is fairly uniform and covers practically the total web area. Decreases in lifetime occur only along the dendrites, the fillet region or along the edges where the web section was cut by the dicing saw. This result is unique and relates to the special crystal structure of the "perfect" web. The defect planes, sandwiched between the perfect web surface layers, provide for "internal" gettering during high temperature heat cycles. Thus a substantial improvement of minority carrier lifetime can result.

The data given in Figs. 8 and 10 are representative of "perfect" web and Czochralski silicon wafers. We note a basic difference between these two materials. Oxidation increases generation lifetime in Web but decreases the

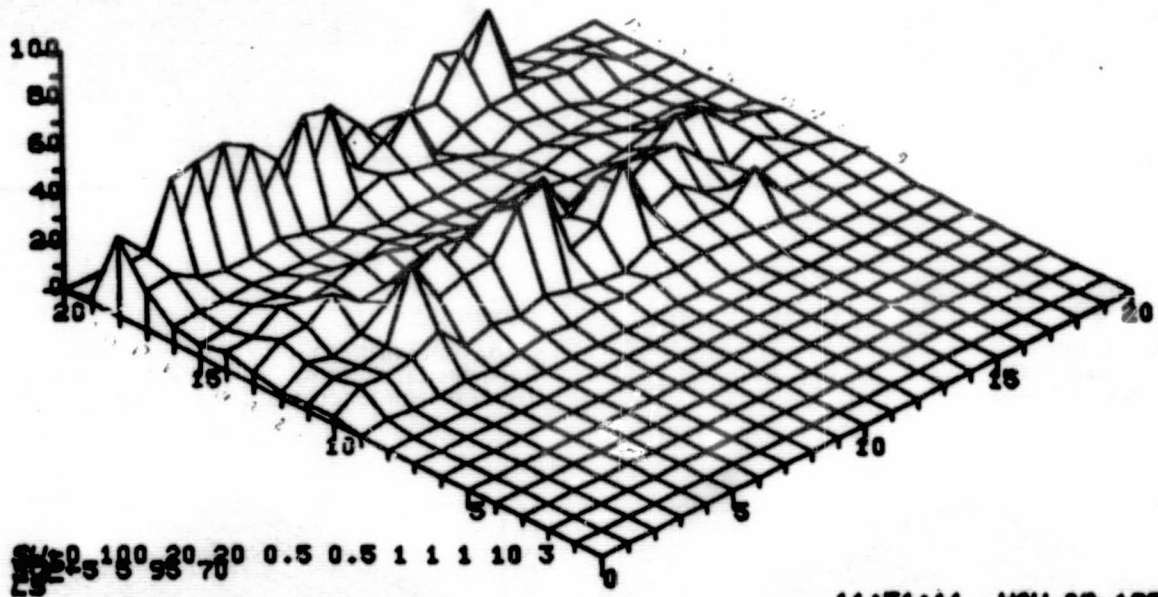
WAFER ID: 459
VENDOR:
FILE RECORD: GA135 LIFE1
NO. OF OXIDATIONS: 1
THICKNESS (A): 4800
DATA RANGE: .1160 50
Z-SCALE : MICROSECONDS

Fig. 9 Minority carrier lifetime map of low performance web. Corresponding SOT topograph is shown in Fig. 7b. Note correlation between dislocation density and low lifetime. Lifetime range: 0.1 - 50 μ sec.

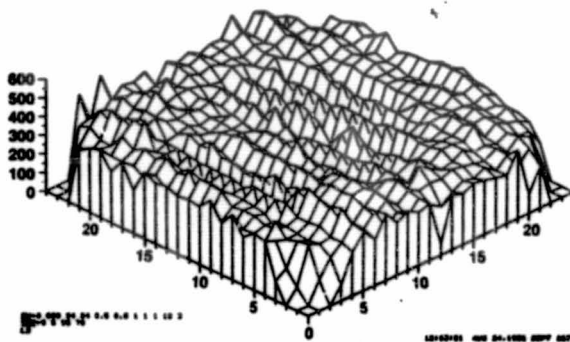
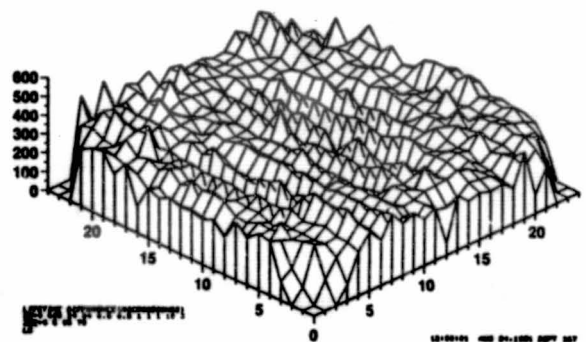
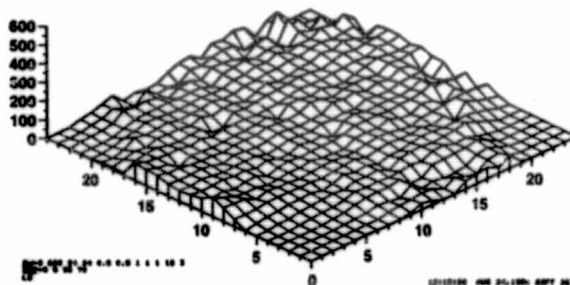
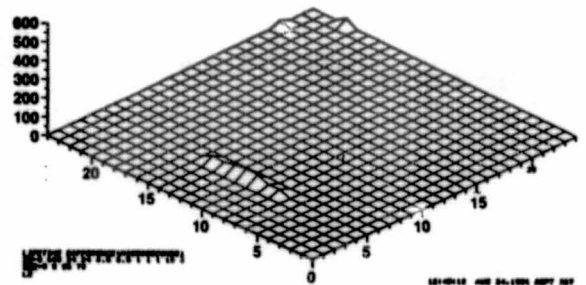
Lifetime Data Distribution Map Vendor B

Oxidation 1

Decrease

Oxidation 4

Increase

Fig. 10 Minority carrier lifetime map of Czochralski wafer for comparison.
Lifetime range: 478 μ sec.

Recently, we conducted an evaluation of 100 mm diameter Czochralski silicon wafers as available from major vendors throughout the world. The evaluation concentrated on minority carrier lifetime mapping as described for the web crystal. Four consecutive oxidation cycles were used. The MOS dot matrix consisted of 25 times 25 MOS capacitors of 1.5 mm diameter. A result typical for the evaluated Czochralski wafers is shown in Fig. 10. The lifetime data shown in Fig. 10 are displayed in 4 maps. The maps on the left carry again the oxidation number. The data obtained after the first oxidation indicate excellent wafer quality. The map has a plateau at approx. 250 to 300 microseconds and extends practically across the total wafer area. This wafer represents silicon of the best quality. Nevertheless, successive oxidation results in steady degradation of lifetime. This is seen by comparing the maps obtained after the first and fourth oxidation.

Interesting are the DECREASE and INCREASE maps shown on the right of Fig. 10. The decrease map confirms that degradation occurs uniformly across the total wafer area. After the fourth oxidation cycle small lifetime increases are observed only at 9 locations. In all other areas lifetime degraded substantially.

same lifetime in Czochralski material. The decrease in lifetime in Czochralski wafers correlates with the precipitation phenomena of oxygen in silicon (7).
